Rainbow SkyReach (Pty) Ltd

SAFETY DIRECTIVE (Various fatigue findings on high hour aircraft)

IMPORTANCE	MANDATORY
AREA AFFECTED	VARIOUS
SA/B NUMBER	CH 21-06-2024
EFFECTIVE DATE	22 June 2024

All Cheetah/Cheetah-XLS/BushCat aircraft.

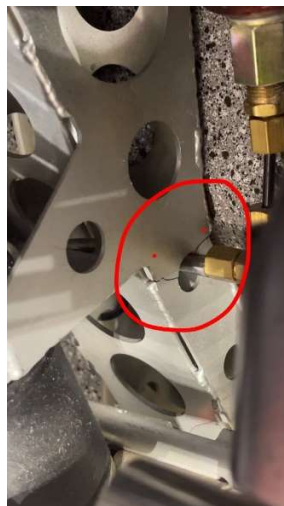
Figure A 1 – Examples of cracks found on engine mounts/front fork assembly

The photos above show cracks in part number BC-A1-41000 (Engine mount and nose wheel fix point). While all recently observed failures of this nature have only been found on nose wheel equipped aircraft, It is imperative that tail wheel equipped aircraft engine mounts (part number BT-A0-12000) are inspected for same. It is presumed that the crack relates to stress incurred by the nose wheel strut on harder than average landings, there is however no firm evidence to support this hence the inspection required on all aircraft

(All mention of part numbers relating to engine mounts are for the latest version/design of this part and for use with Rotax 912 series installation. ALL engine mounts must however be inspected regardless of version or motor installed.

Cracks found in the areas of concern highlighted by this document, regardless of how minor they might be, can lead to structural failure of the aircraft. Any such findings, no matter how small the cracks may appear, should be addressed and aircraft should not be flown until the affected parts have been replaced.

- Operator to remove upper cowling of the aircraft and conduct a thorough inspection of the engine mount forward and aft (cabin side) of the firewall.
- The entire engine mount assembly must be inspected under good lighting conditions (use a flashlight/torch and mirrors if necessary) for cracks or any other defects.
- Ensure parts are clean to allow for a thorough inspection.
- Any cracks found regardless of how small they may appear requires replacement of the engine mount.

- If there is any evidence of a crack or defect, contact SkyReach for replacement parts to be ordered. (contact details below).

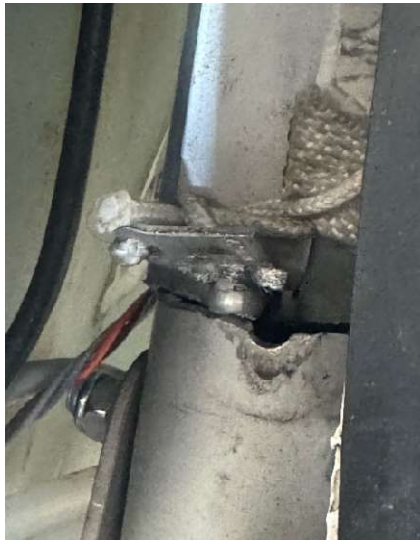
Figure B1 – example of failure found

The photos above show cracks/failures in part number BC-00-12230-01/02 “Back Cabin Struts L/R”. These are again the part numbers relating to the nose wheel version of the aircraft.

The tail wheel equipped aircraft is fitted with similar “Back Cabin Struts” but due to minor differences, are allocated part number BT-00-12130-01/02 (L/R). We do not have history of such a failure on a tail wheel equipped aircraft but it remains crucial that the inspection is done on all aircraft regardless of configuration.

6.1 Operator to inspect visually for cracks/defects in the “Back Cabin Struts”

- Shift both seat backs forward to allow better access to the area.
- Use a torch/flashlight and mirror if required to inspect the entire strut/tube
- Pay specific attention to the top and bottom of the tube as well as the area highlighted in the picture.
- Check for any excess play on the struts by firmly manipulating them by hand.
- Check for signs of elongated bolt holes within the struts.
- If there is any evidence of a crack or defect, contact SkyReach for replacement parts to be ordered. (contact details below).

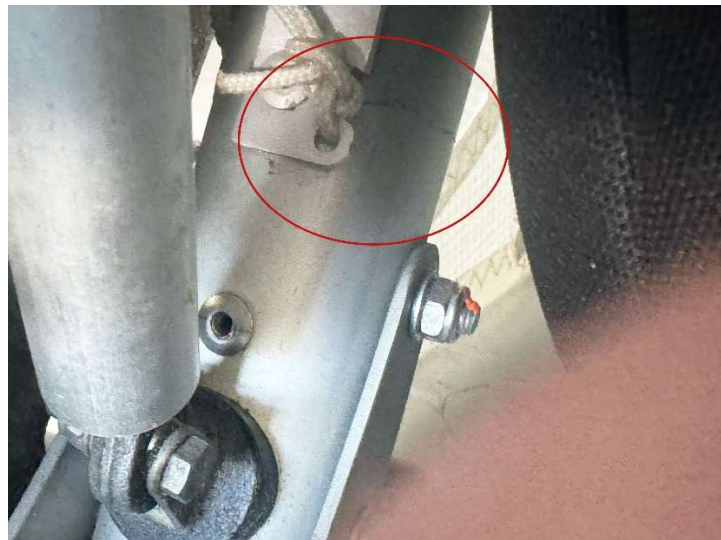
Figure B2 – Crack that will lead to failure

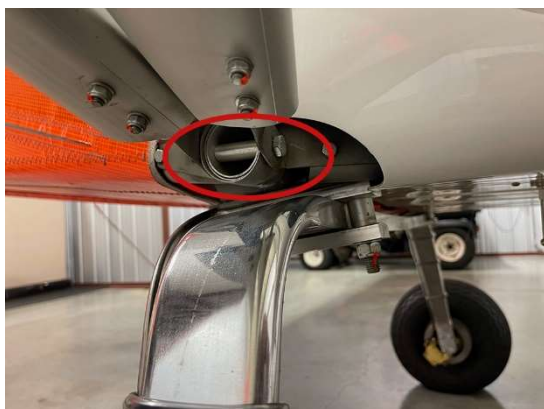
Figure C1 – overview of area of concern.

The photos above show multiple cracks in the “Bottom Side Cabin Bracket”. It is important to note that most of these are more visible when viewed from below which may require a mirror or laying down on the ground to view properly.

The brackets are part number BC-00-12060-01/02 (L/R) on Nose wheel equipped aircraft and BT-01-12120-01/02 c(L/R) for tail wheel equipped aircraft. Again while the cracks were found on a nose wheel equipped aircraft, it is imperative that the equivalent bracket is inspected on tail wheel equipped aircraft.

6.2 Operator to inspect visually for cracks/defects in “Bottom Side Cabin Joining Brackets”

- This may require sitting on the floor next to aircraft to action a thorough inspection.
- The use of a flashlight/torch and mirrors may assist in completing the task in a detailed fashion.
- Check for signs of cracks or any other defect paying particular attention to the areas highlighted in the photos above.
- If there is any evidence of a crack or defect, contact SkyReach for replacement parts to be ordered. (contact details below).

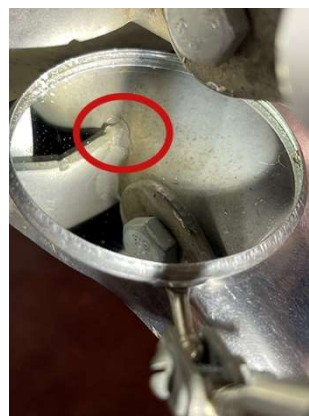
Figure C2 – viewed from ground up. (Mirror view)

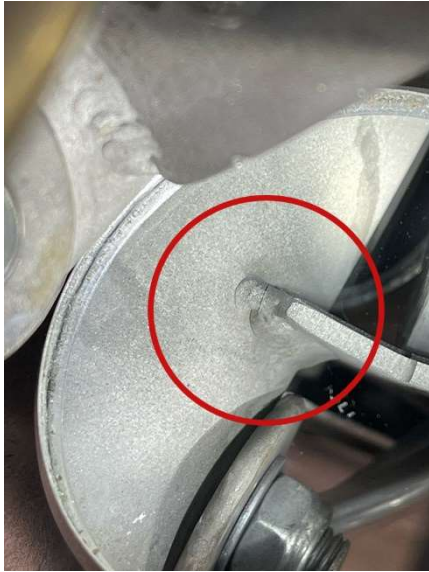
Figure C3 – visible crack on Bracket (Mirror view)

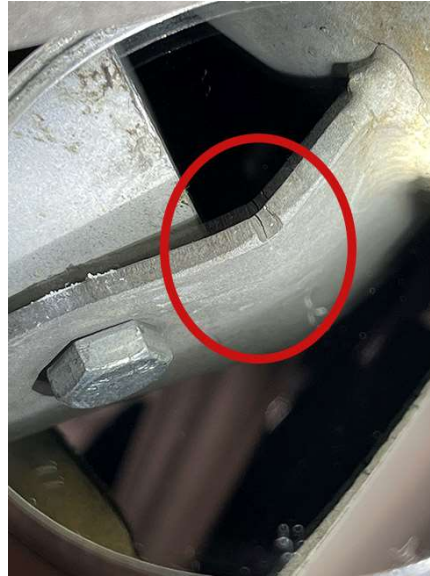
Figure C4 – visible crack on bracket. (Mirror view)
